STAPLETON INTERNATIONAL
AIRPORT

★
GROUND WATER
MONITORING

★
SOUTHERN TIER OF
ROCKY MOUNTAIN ARSENAL

February 1987

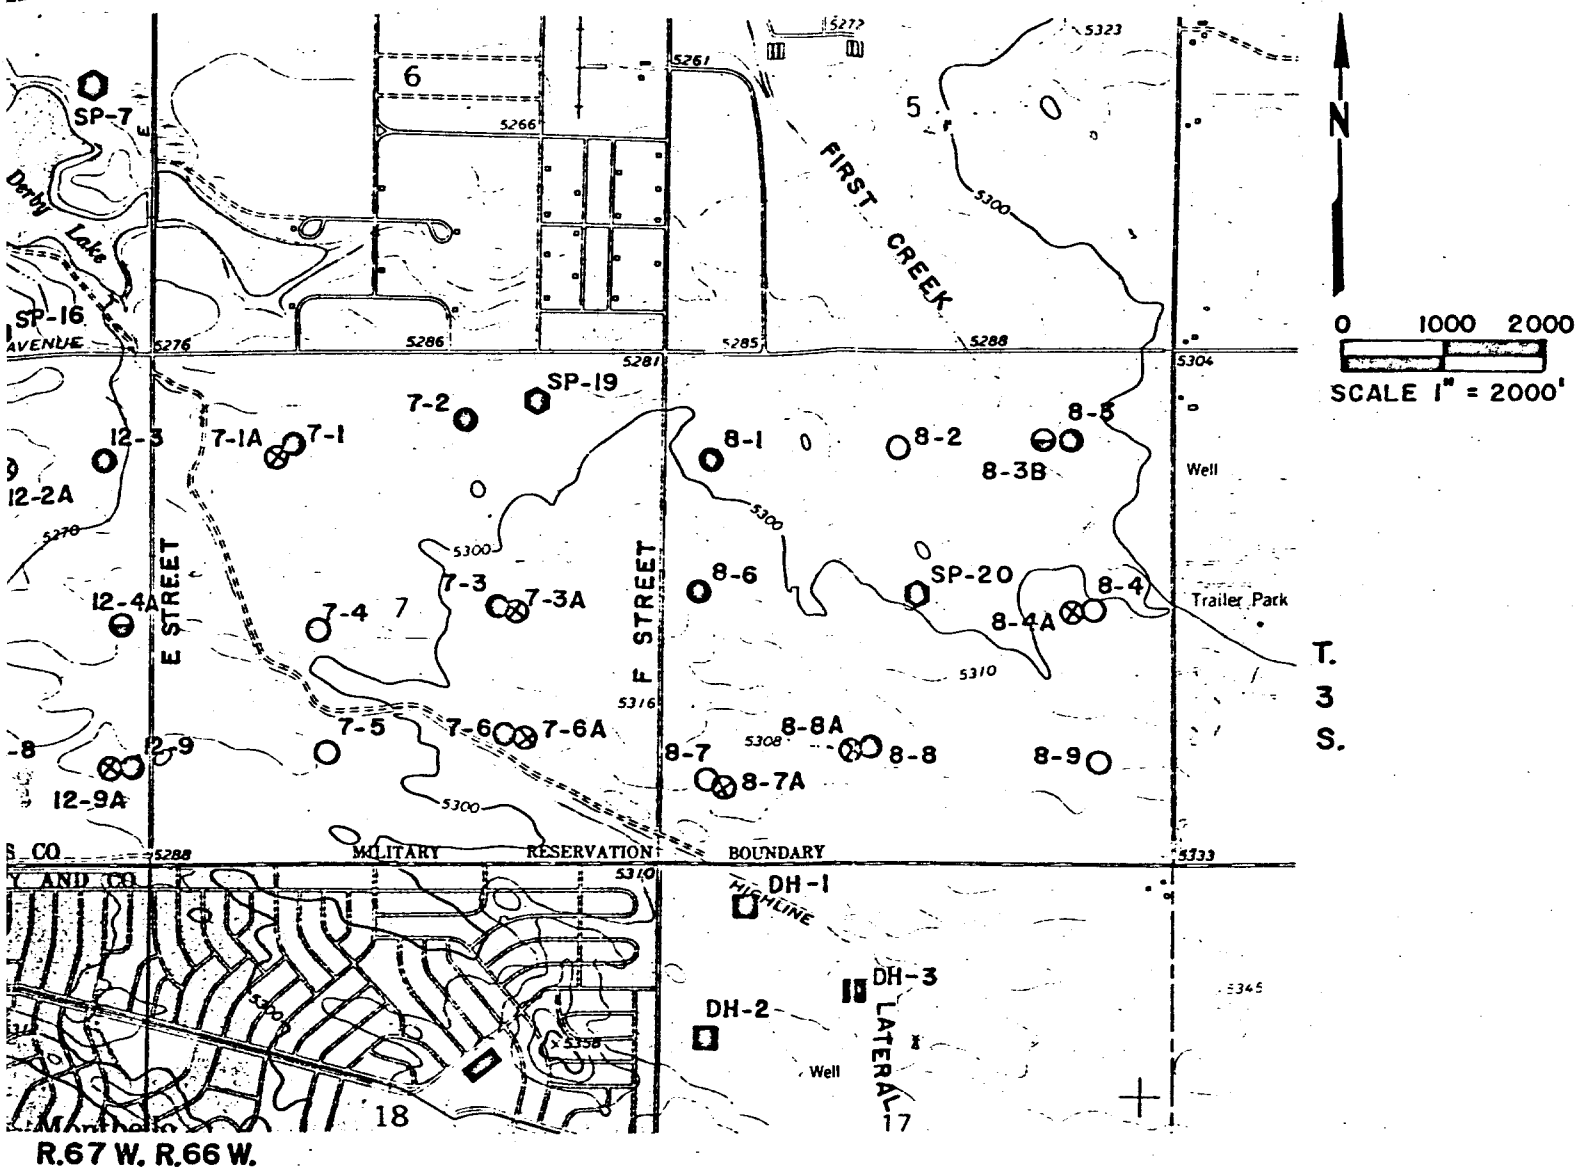
FIGURE 2

This study included monitoring the ground water levels on the Southern Tier monthly for one year and bimonthly after the first year. The field work consisted of monitoring 61 new and existing water level test/monitor holes completed in the alluvial aquifer underlying the southern tier of the Rocky Mountain Arsenal. (See Figure 2)

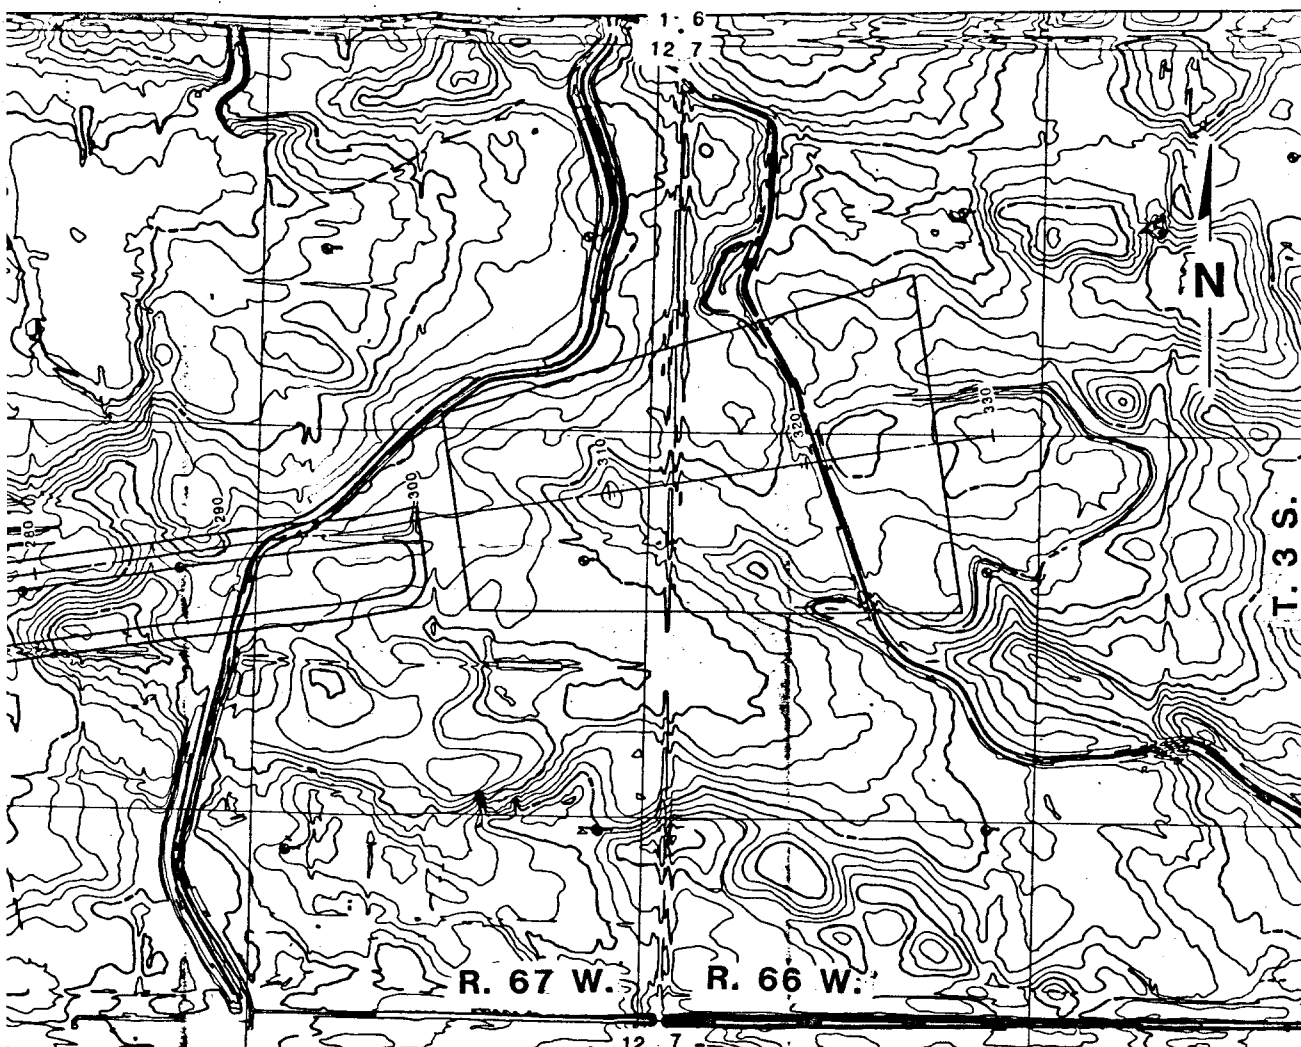
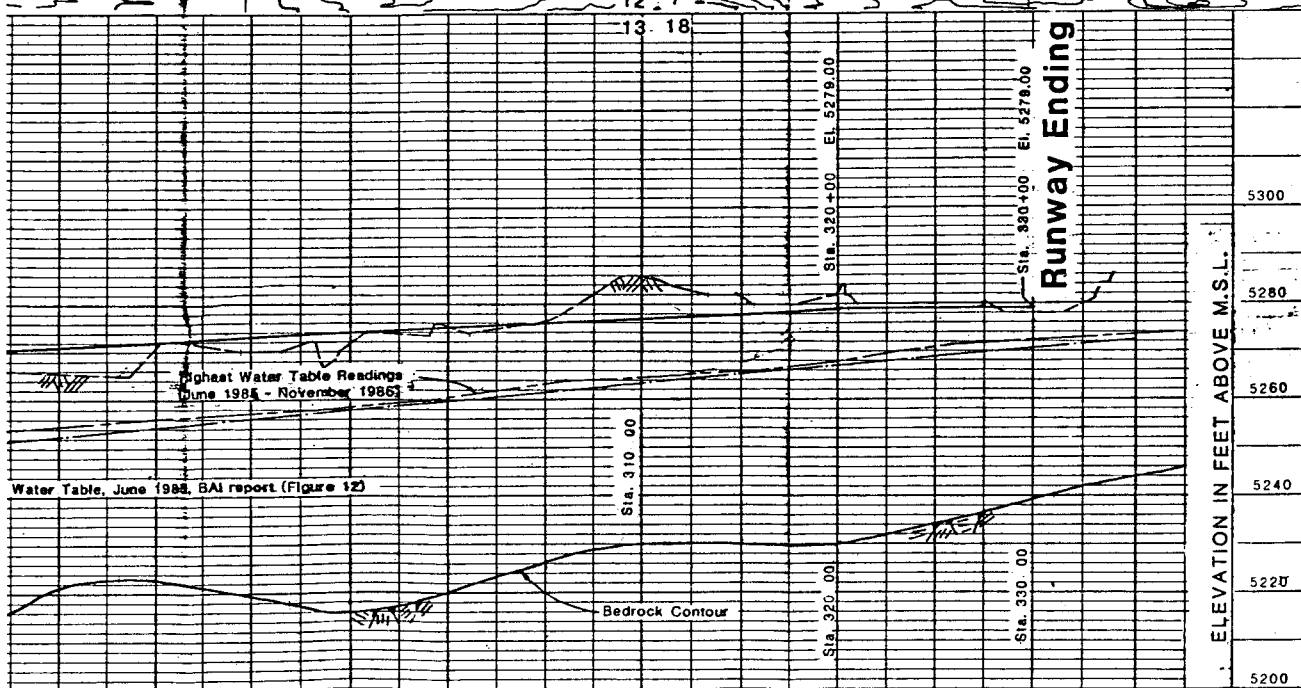
GROUNDWATER/BEDROCK PROFILE
EAST-WEST RUNWAY 9.5° CANT
 STAPLETON INTERNATIONAL AIRPORT
 SOUTHERN TIER OF ROCKY MOUNTAIN ARSENAL

The results of the investigations are presented in profile in Figure 3 showing the initial configuration of the alluvial ground water table and bedrock beneath the selected runway alignment (9.5° Cant). This data provides the basis for the conclusions and recommendations. Figure 3 also shows the approximate location of the selected runway alignment.

(1) The water table for the East-West Runway configuration, 9.5° Cant, does not present an immediate problem from the standpoint of having to dewater for the normal runway construction. Areas of the proposed runway alignment in which the water table is nearest to the surface are in areas where the fill for the runway will be most extensive. The construction and/or operation of structures under the runway may be affected by ground water depending on where the structures are located.

(2) It is recommended that when the field investigations for the design of the selected runway proceed, that observation holes be established only for Station 217+00 through Station 234+00 and Station 245+00 through Station 265+00. Once the water table has stabilized in the test holes, one or two readings should be sufficient to verify the water table location for construction purposes.

(3) The design of structures under the runway should take into account the potential of ground water interference in the construction and operational processes.
